**HIGHWAY 21 LAKE DAM  
JEFFERSON COUNTY, MISSOURI  
MO 31402**

**PHASE 1 INSPECTION REPORT  
NATIONAL DAM SAFETY PROGRAM**

HIGHWAY 21 LAKE DAM  
MISSOURI INVENTORY NO. 31402  
JEFFERSON COUNTY, MISSOURI

Name of Dam:	Highway 21 Lake Dam
State Located:	Missouri
County Located:	Jefferson
Stream:	Tributary of Heads Creek
Date of Inspection:	8 October 1980

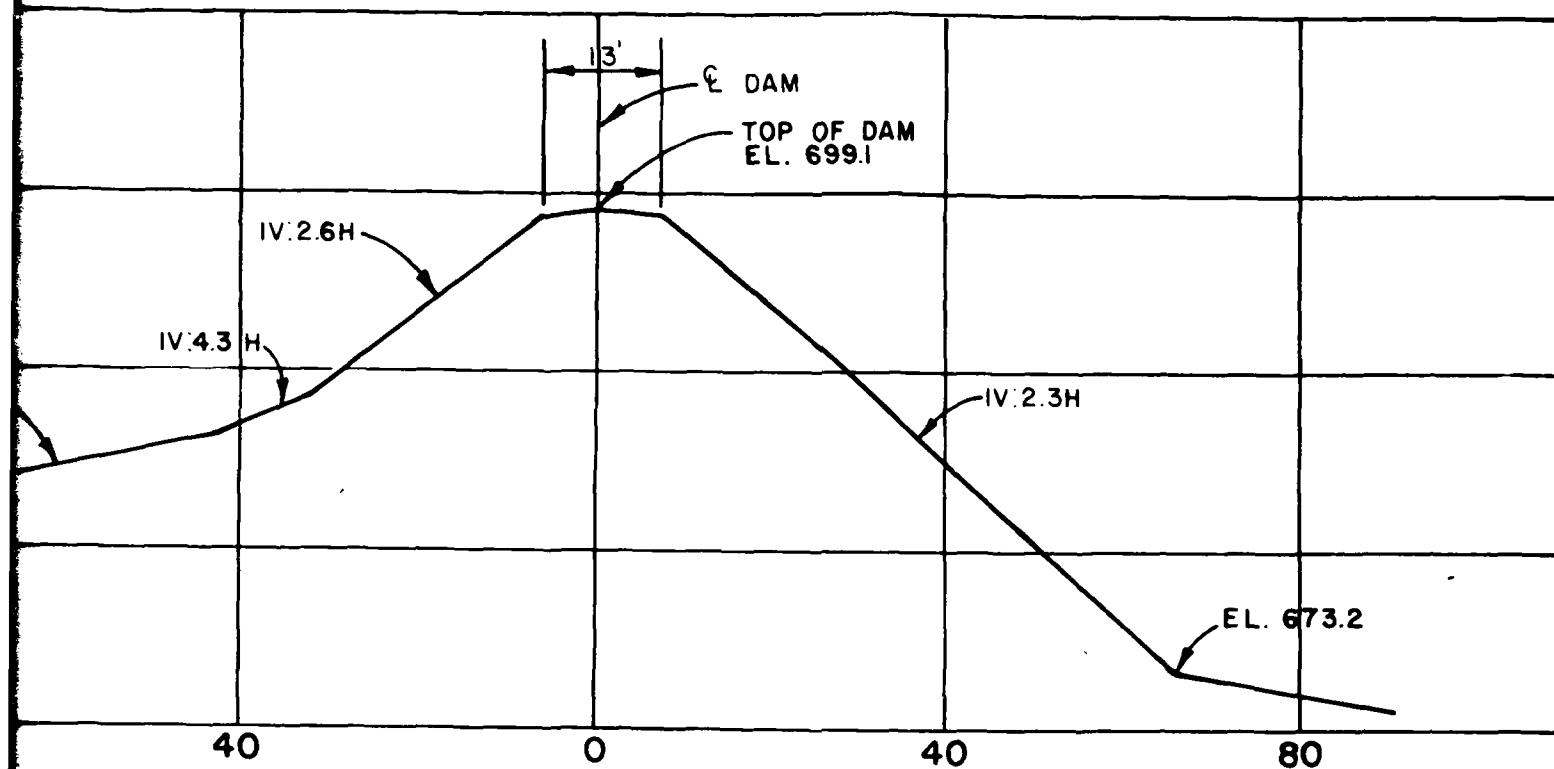
**DAM CROSS-SECTION STA. 2+10**

Elevation 699.1 was found to be the lowest point in the dam crest. The velocity of spillway discharge corresponding to elevation 699.1 was determined to be 4.6 feet per second, which is less than the assumed maximum permissible (non-erosive) velocity of 5.0 feet per second.
